PHASE I ENVIRONMENTAL SITE ASSESSMENT

Pullman Car Manufacturing Company "Pullman State Historic Site" 748 E. 111th St. Chicago, IL LPC 0316505070 ILB 000 000 135

THE OFFICE OF SITE EVALUATION
DIVISION OF REMEDIATION MANAGEMENT
ILLINOIS ENVIRONMENTAL PROTECTION AGENCY
1021 NORTH GRAND AVENUE E.
SPRINGFIELD, ILLINOIS 62794-9276

December 16, 2013

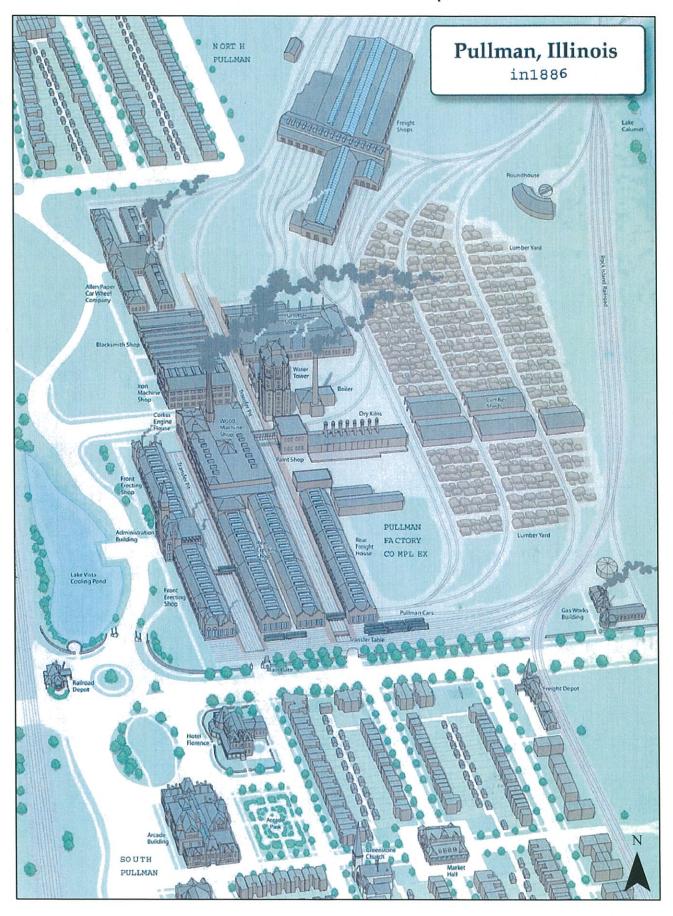
Figure - 5 REC Location Map

of the lake. Due to the unknown nature and origin of the slag, it may be contributing to potential contamination of soil and groundwater. The remains of the lake are now covered by grass and portions of South Cottage Grove Ave (Figure – 5).

During the investigation at the Pullman site, a transformer pit was discovered just east of the Administration Building (Figure – 5). The pit measures approximately 15 feet by 15 feet and is surrounded by concrete on four sides. Due to the historic use of Polychlorinated Biphenyls (PCB's) in transformers, this may be an area of concern that will need to be investigated during Phase II activities.

The investigation also led to the discovery of a large vent pipe protruding from the ground on the east of the Administration Building and just north of the remains of the Rear Erecting Shop (Figure – 5). The vent pipe is a sign of a potential underground storage tank which could potentially contain petroleum or other hazardous substances. If the tank is present and if leaking, it could potentially contaminate groundwater as well as surrounding soil.

Historical records show that the Corliss Steam Engine was housed to the northeast of the Pullman property, in the boiler room (Figure – 5). The Corliss Steam Engine used coal fire and water to create steam that was utilized by the Pullman Factory for power. The use of

Sometime around 1957, an automobile/truck repair shop was opened in an area near the Rear Erecting Shop and remained in business until the early 1990s (Figure – 5). It is unknown what services were offered by the repair shop which could give rise to multiple potential contaminants released. It is highly likely that oil and grease have leeched into the soil surrounding the repair shop. Other chemical hazards may include volatile organics from paints, fillers and solvents that may have been released or disposed of during automotive repair.

products, or controlled substances on the subject property. However, five or six potential recognized environmental conditions were identified on the subject property during this assessment. Given the fact that these conditions exist, the Illinois Environmental Protection Agency recommends that a Phase II investigation be conducted on the property.

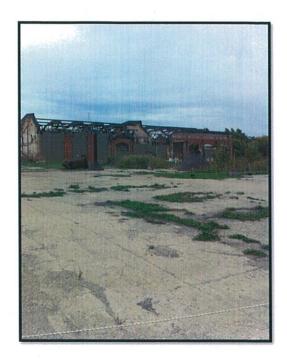
Photo No: 1

Comments: Photo taken southeast towards the rear of Pullman site. Photo shows the remains

of the Rear Erecting Shop

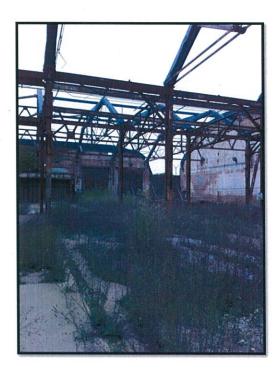
Photo No: 2

Comments: Photo taken inside the building

facing north.

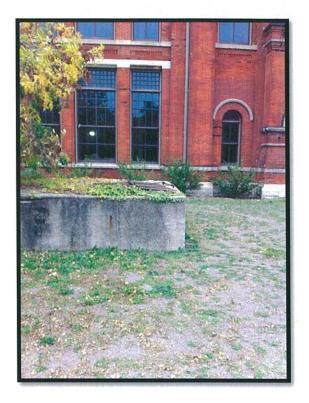
Photo No: 3

Comments: Photo taken of transformer pit sitting in from of the Administration Building.

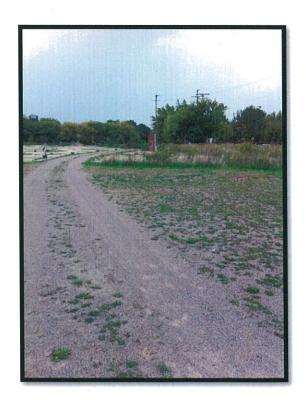
Photo No: 4

Historical records show that from 1881-1899, Lake Vista, a manmade lake was created and stood in front of the Administration Building. The lake was used as a cooling pond for the Corliss Steam Engine as well as a reflecting pool for the clock tower. In 1899, the lake was filled with slag (byproduct of steelmaking) and debris brought in from a nearby steel manufacturing company, Acme Steel. A five inch layer of topsoil caps the previous location

Comments: Photo taken in front of

Administration Building, looking to the south.

Overlooks dirt walking pathway as well as parts

of where Lake Vista stood.
